**CONSENT ORDER
ISSUED UNDER THE
WATER POLLUTION CONTROL ACT
WEST VIRGINIA CODE, CHAPTER 22, ARTICLE 11**

TO: MarkWest Liberty Midstream & Resources, L.L.C. DATE: March 28, 2019
Gregory Bezdek, SVP, NE Region
4600 J Barry Ct. Ste 500
Canonsburg, PA 15317 ORDER NO.: 8945

MARKWEST LIBERTY MIDSTREAM & RESOURCES, L.L.C, WVR311004, Sherwood to Mobley
20" NGL, 8/22 & 8/23/2018

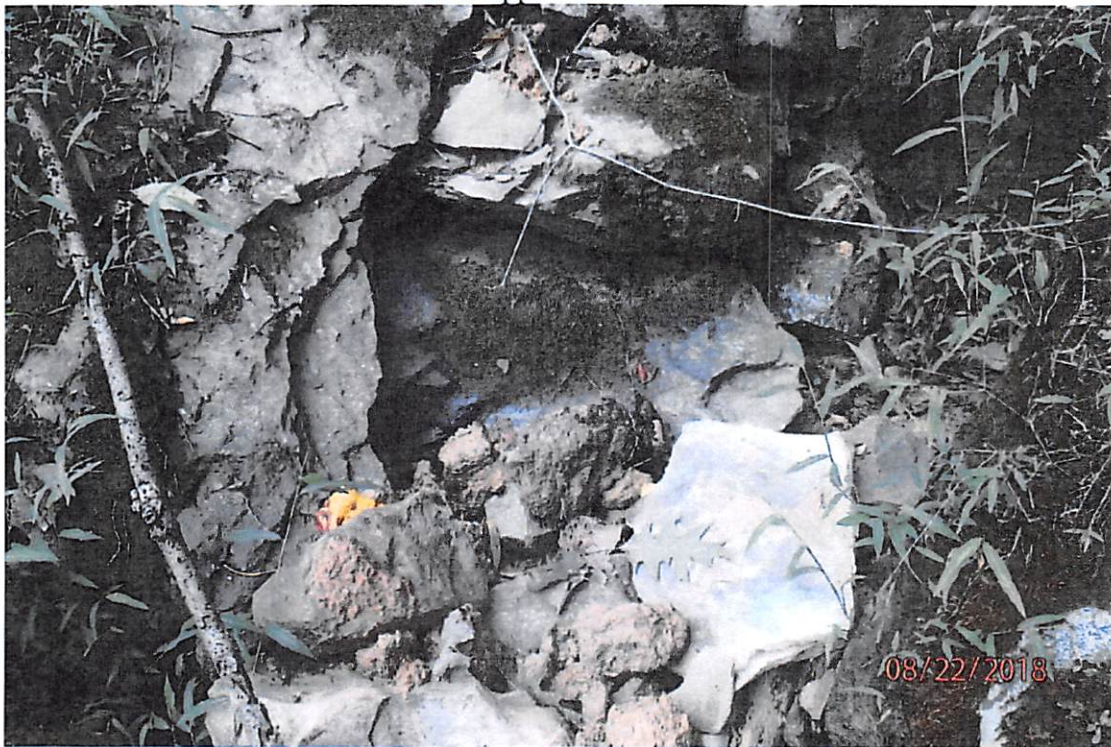
CNA deposits in UNT Flint Run (UNT 94 near 272+00) ($39^{\circ} 20.051'$ X $80^{\circ} 39.945'$).

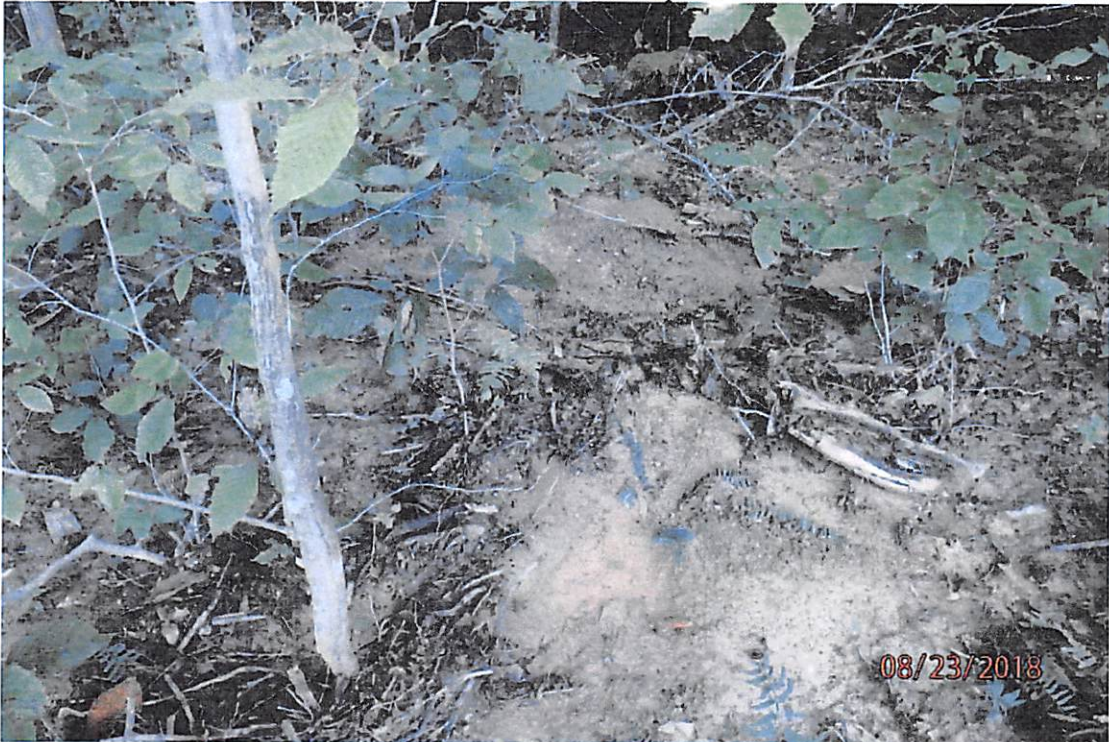
Offsite sediment deposits that lead to the receiving stream as a result of the above pictured deficiency.

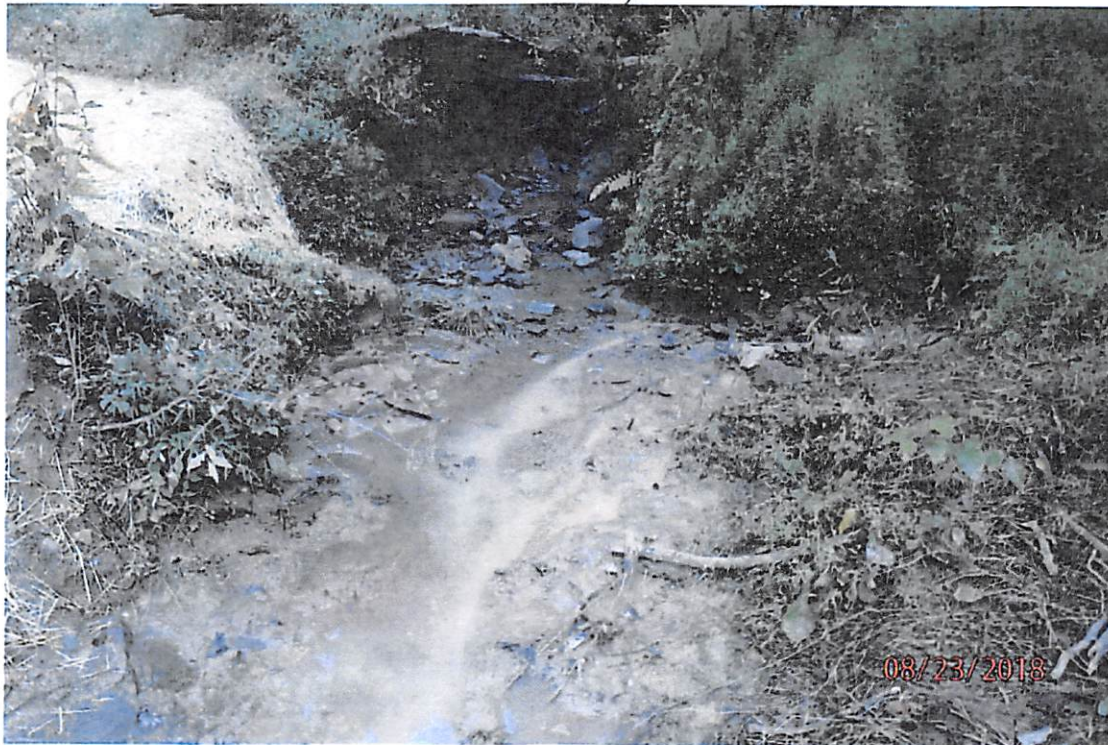
CNA deposits and distinctly visible settleable solids in UNT Beverlin Fork (UNT 129) ($39^{\circ} 26.346'$ X $80^{\circ} 36.157'$) as a result of the previously pictured priority 1 silt fence failure.

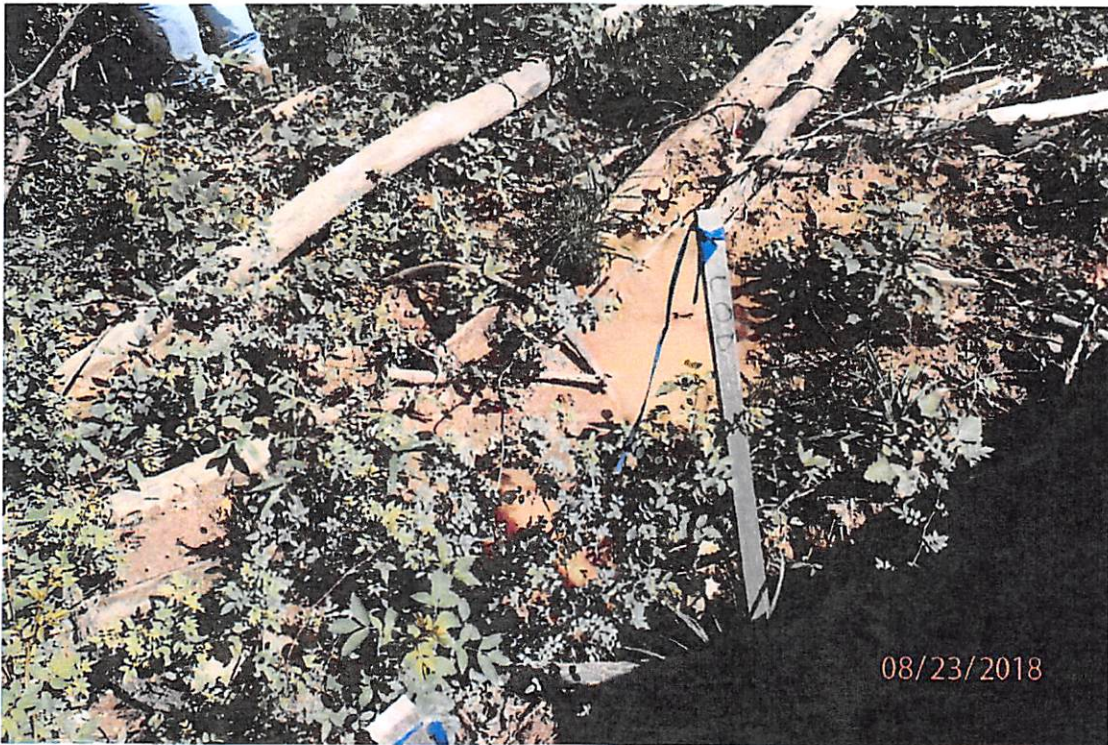
Offsite sediment deposits that lead to the receiving stream as a result of the above pictured BMP.

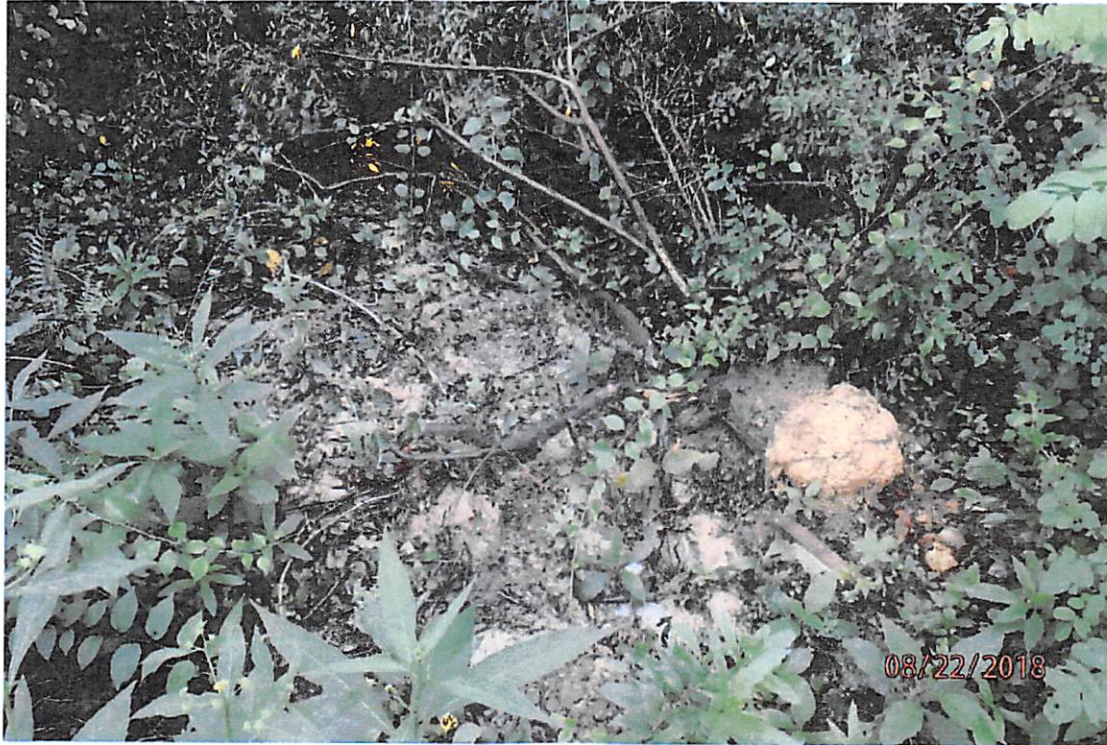
Offsite sediment deposits as a result of the above pictured deficiency.

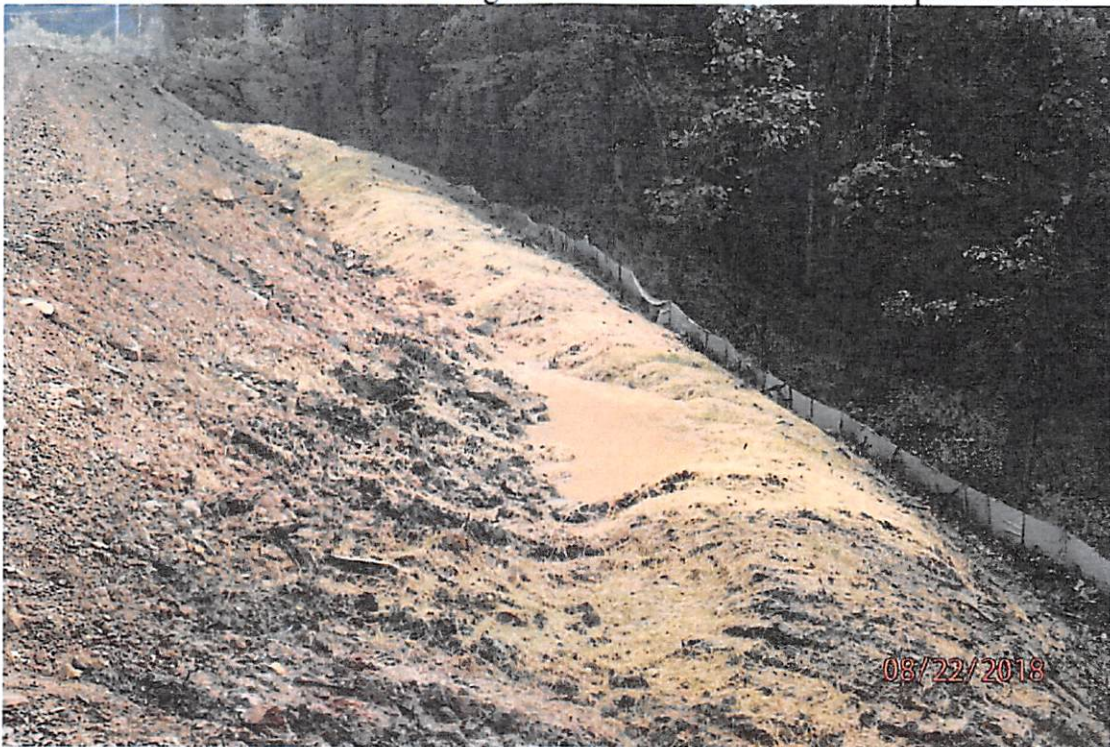
Installed diversion berm in the Morgans Run watershed that lacks adequate outlets.

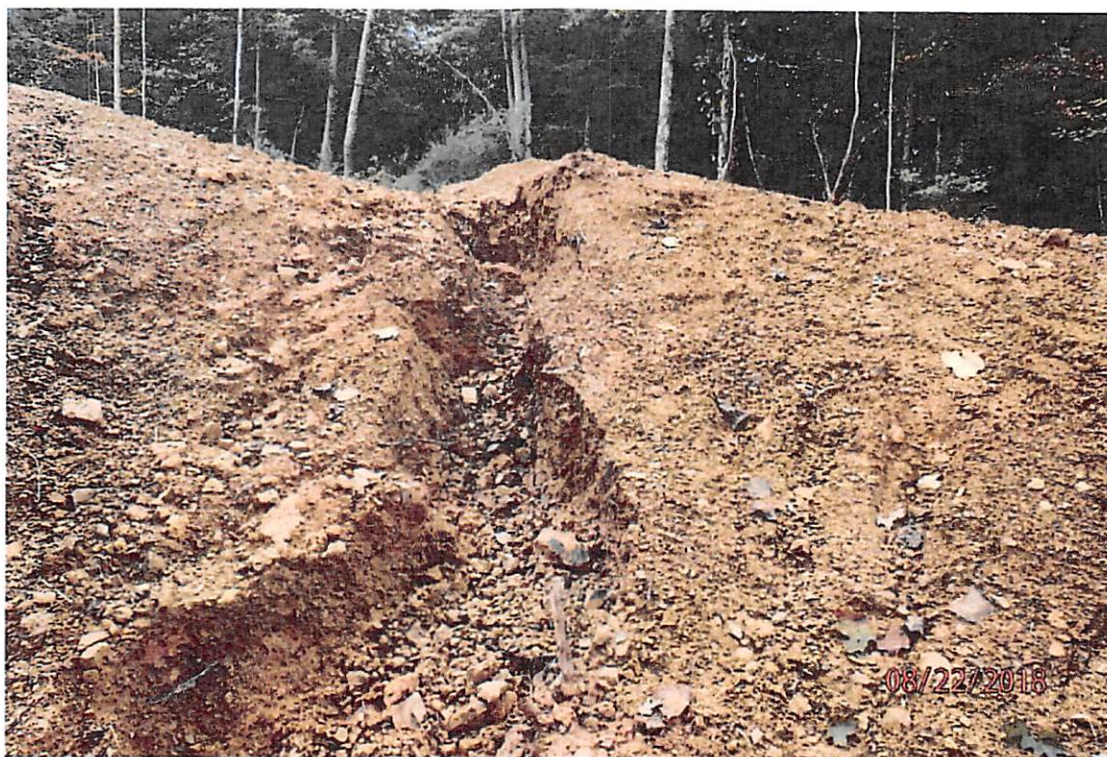
Fill slope erosion adjacent to UNT 108 as a result of concentrated flow from a water bar outlet.

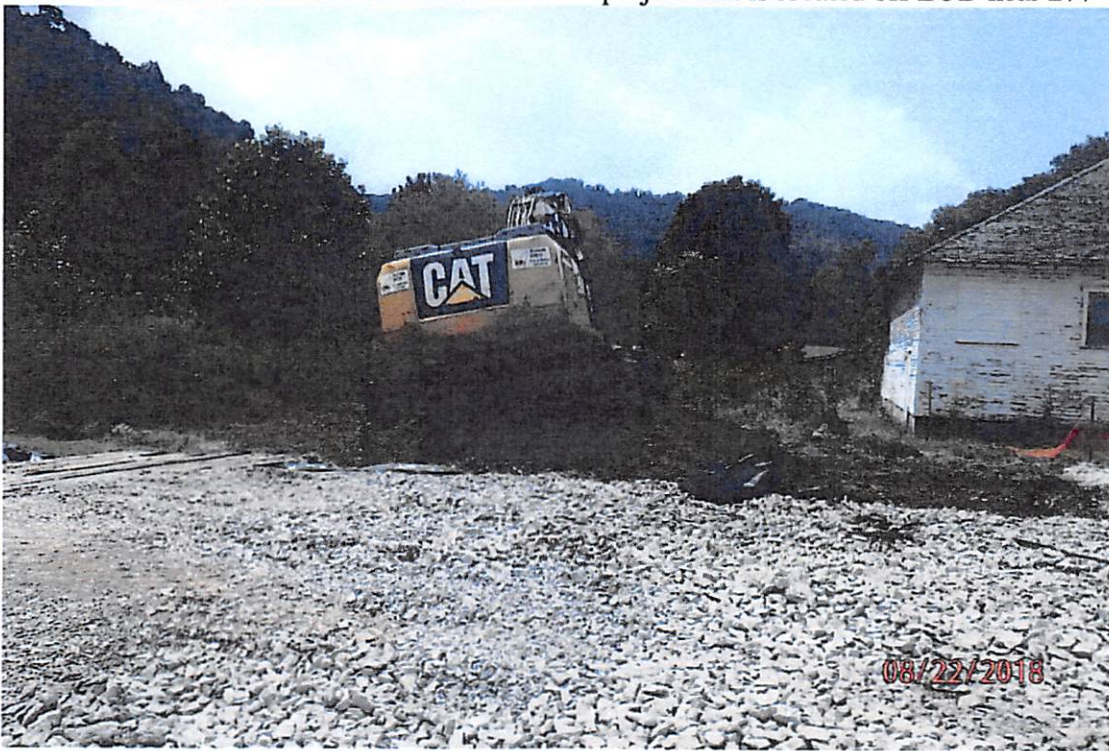
Overview of construction work associated with the project that is located off LOD near 277+00.

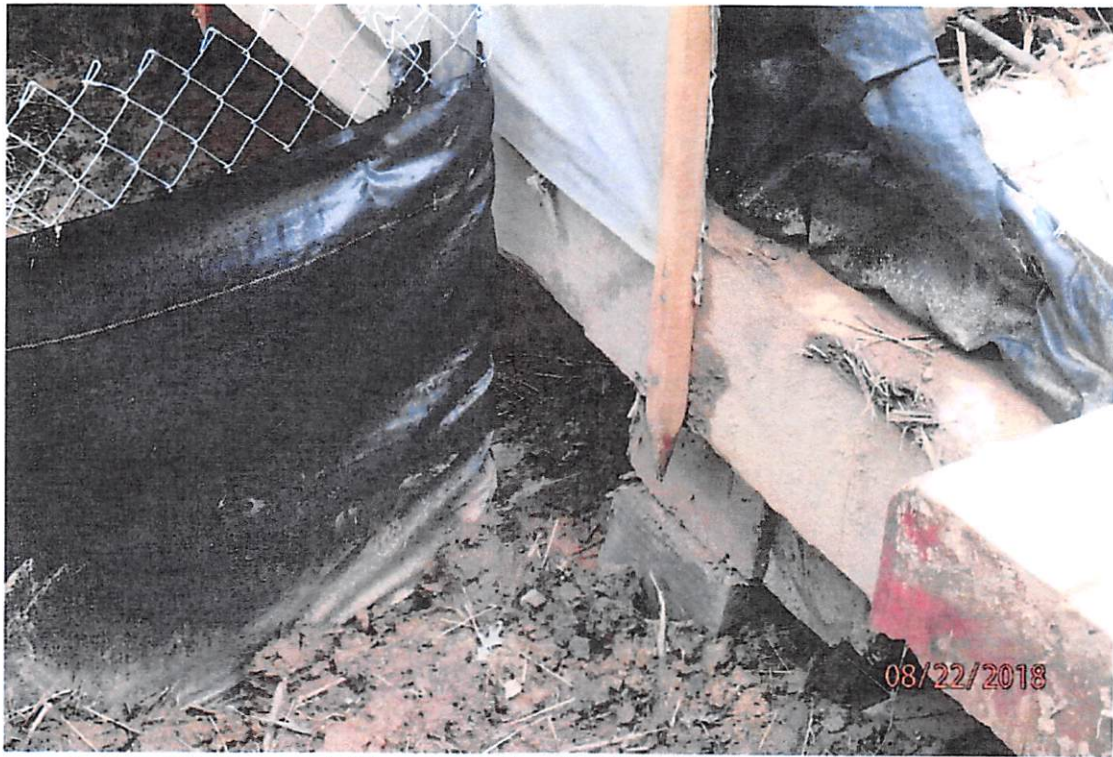
Installed timber mat bridge at crossing 41 (UNT 18) that is not tied in properly.

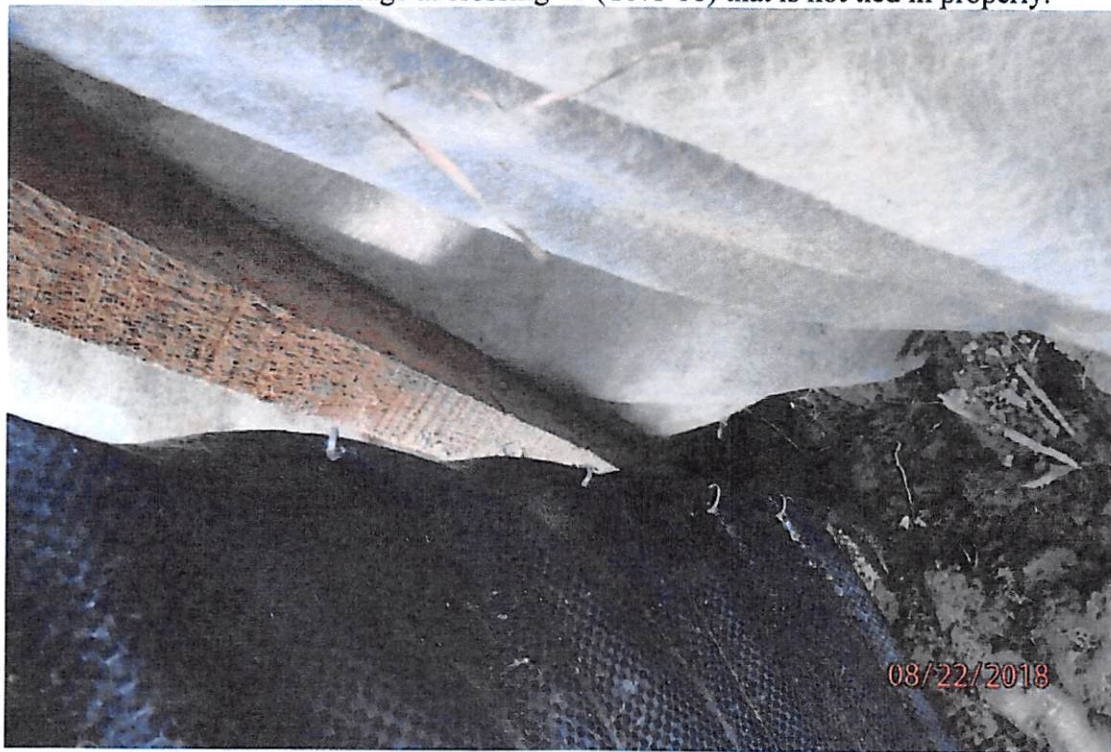
Installed timber mat bridge at crossing 41 (UNT 18) that is not tied in properly.

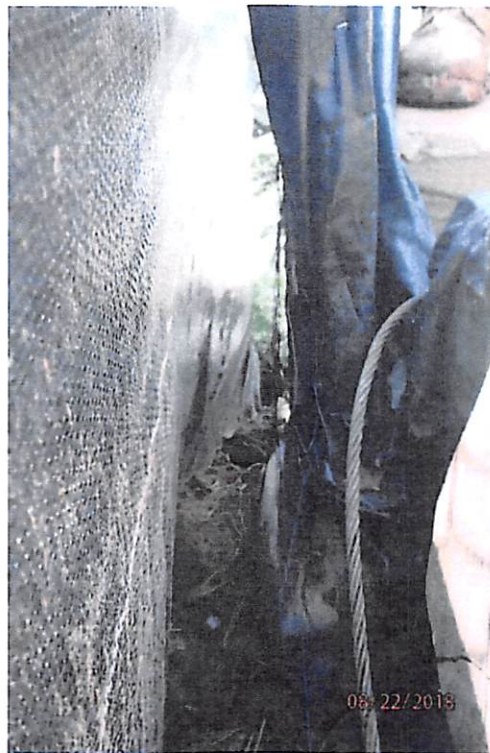
Installed timber mat bridge at crossing 43 (Riggins Run) that is not tied in properly.

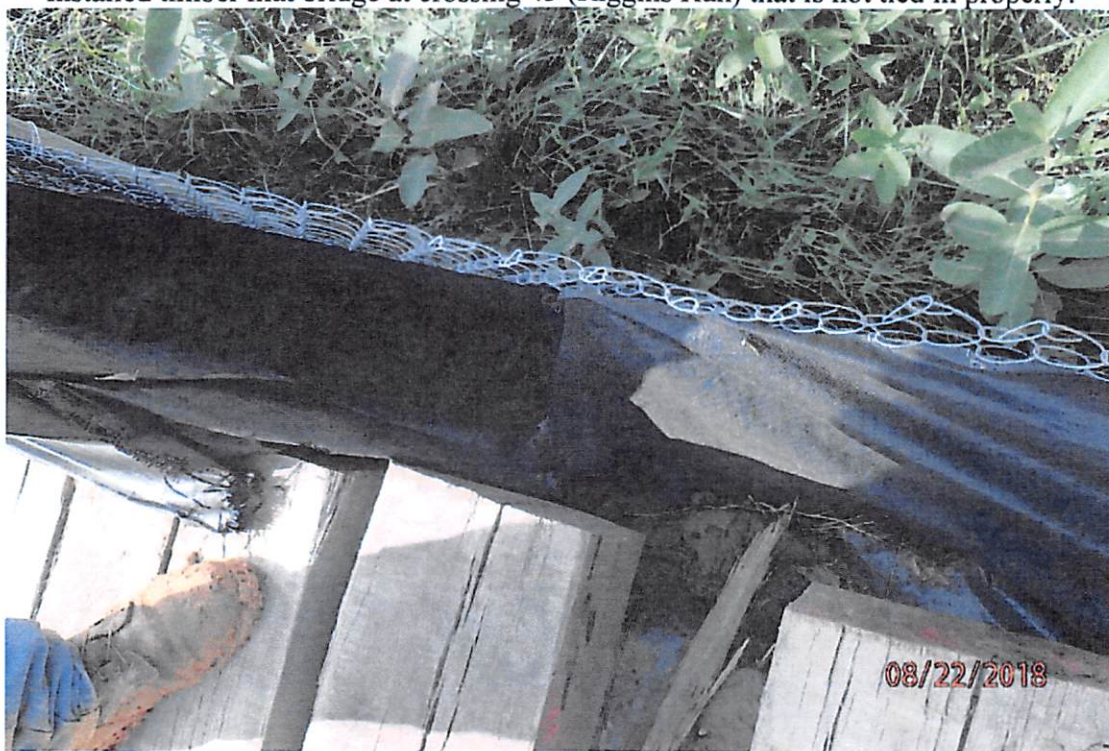
Installed timber mat bridge at crossing 43 (Riggins Run) that is not tied in properly.

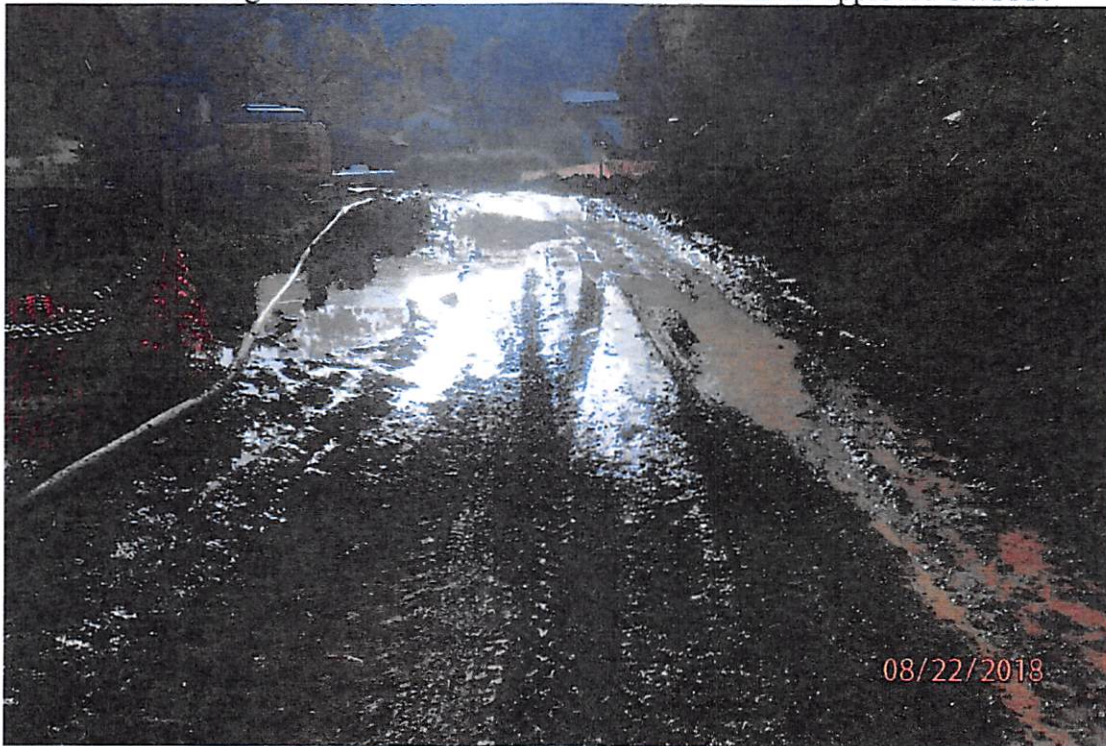
AR 40 showing a lack of stabilization that is described in the approved SWPPP.

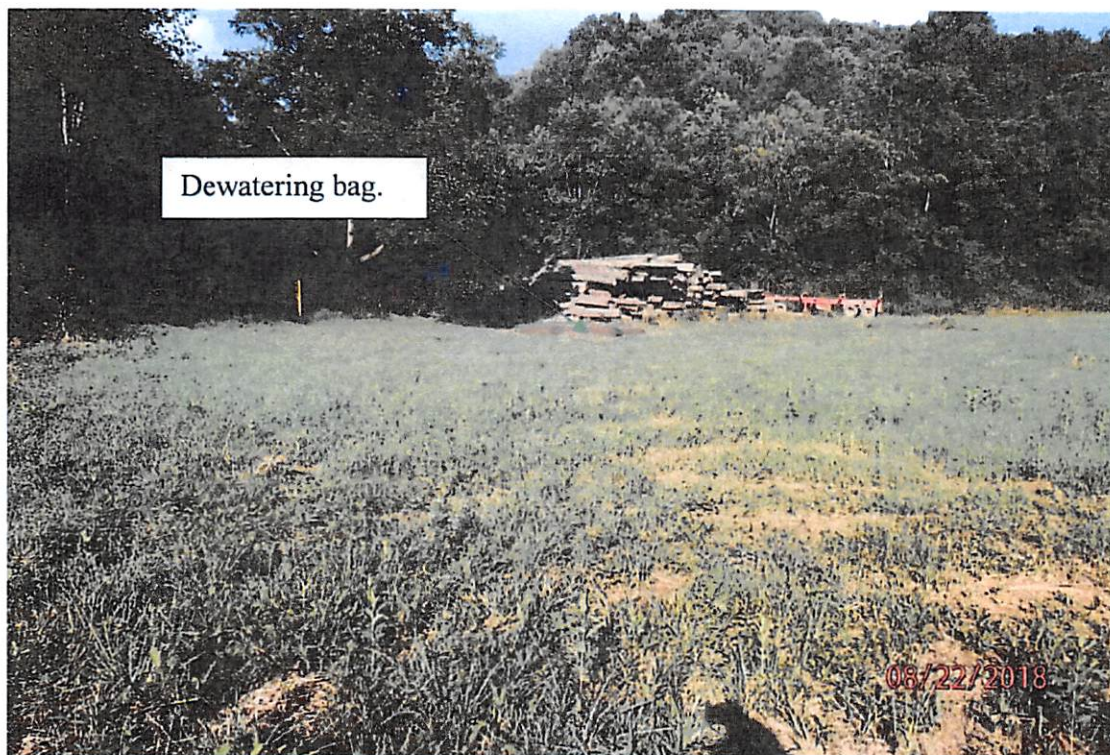
Overview of dewatering BMP adjacent to UNT 127.

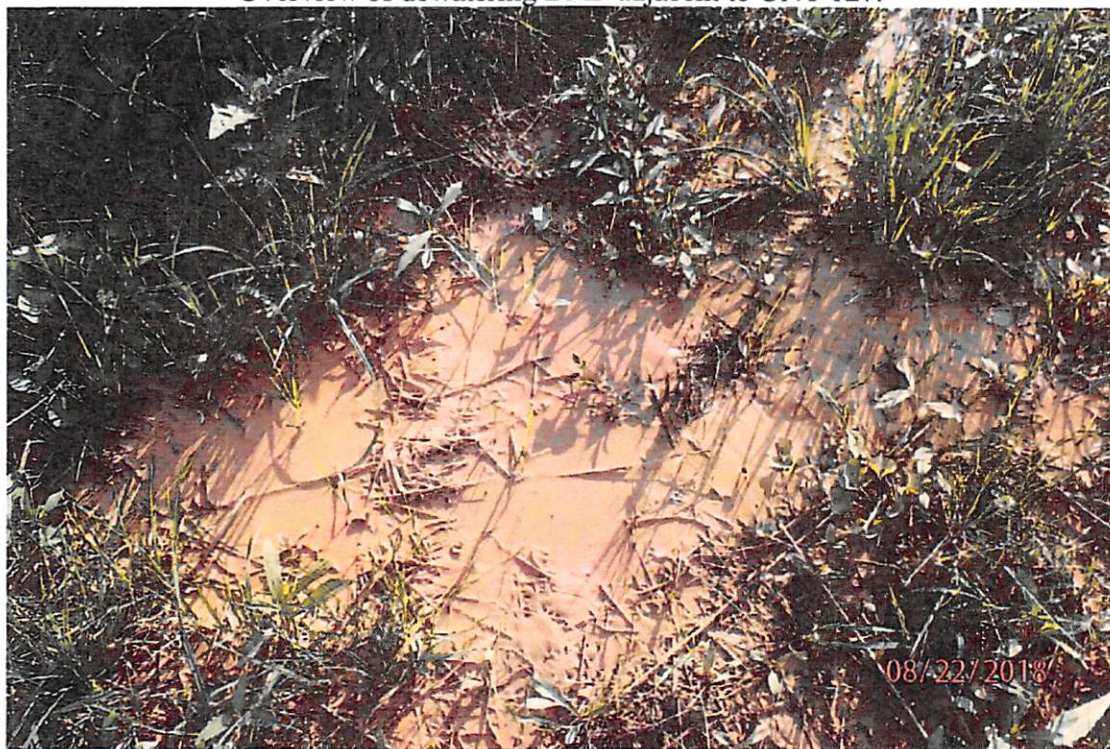
Offsite sediment trail leading from the dewatering bag to the receiving stream.

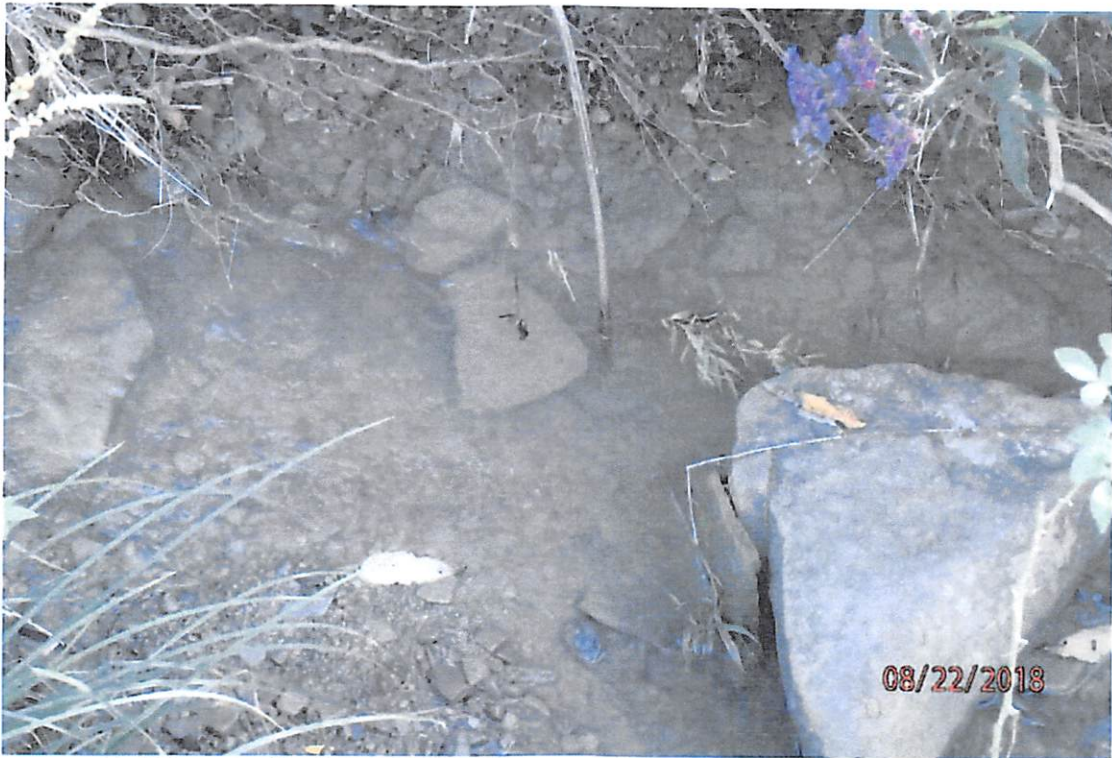
Water quality in UNT Franks Run upstream of dewatering activity.

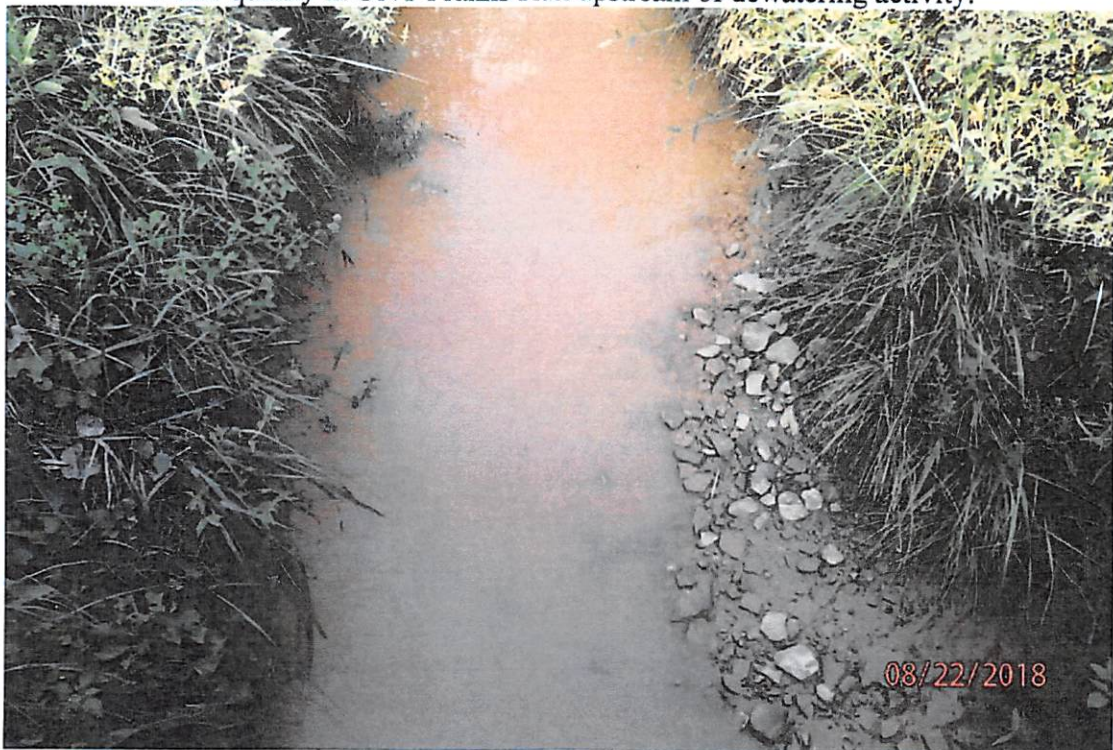
Offsite CNA deposits and distinctly visible settleable solids in UNT Franks Run (39° 26.167' X 80° 36.861') downstream of the dewatering activity.

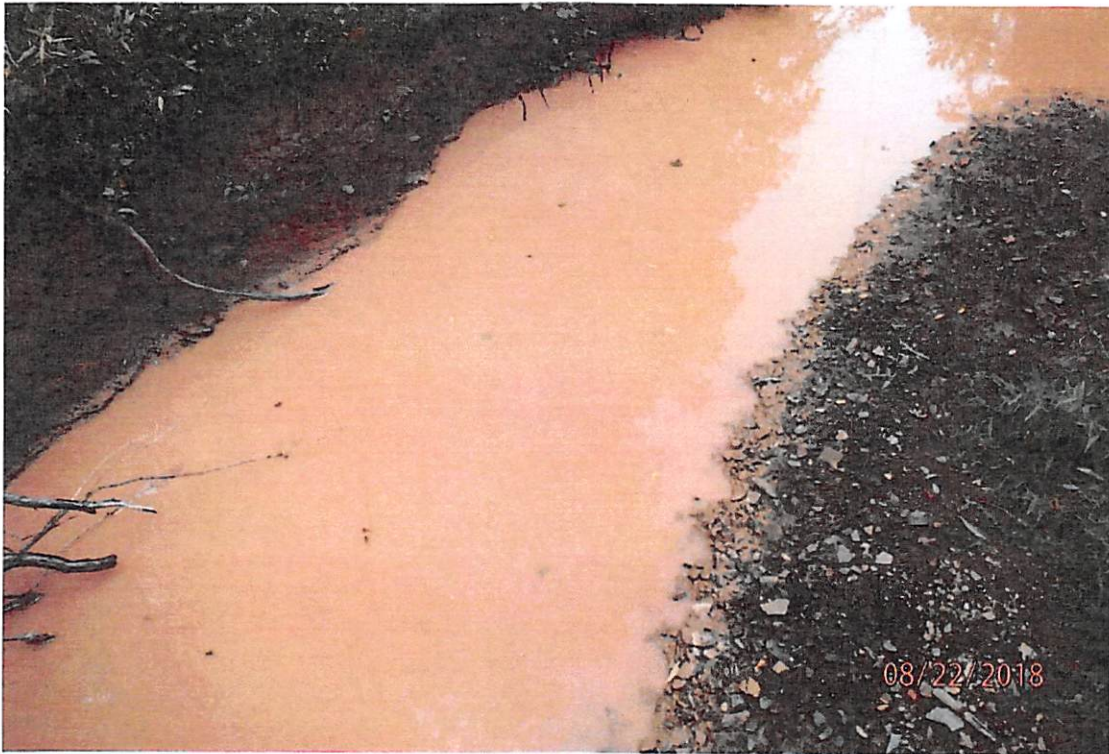
Offsite CNA deposits and distinctly visible settleable solids in UNT Franks Run (39° 26.167' X 80° 36.861') downstream of the dewatering activity.

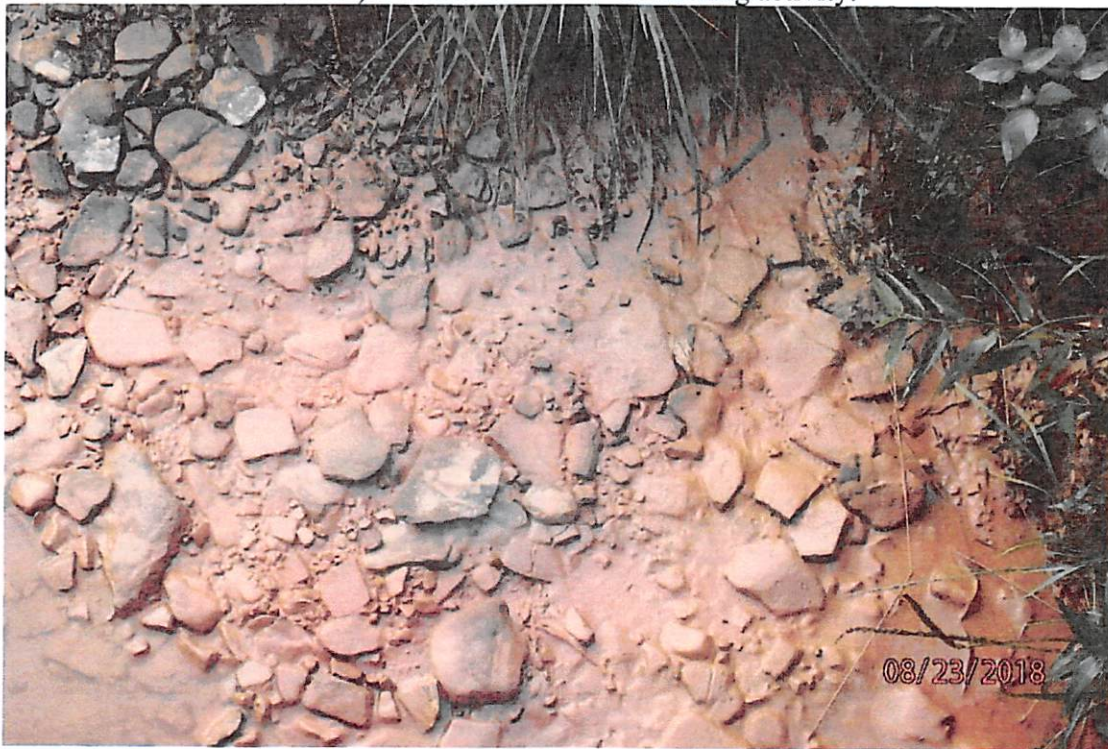
Offsite CNA deposits and distinctly visible settleable solids in UNT Franks Run (39° 26.167' X 80° 36.861') downstream of the dewatering activity.

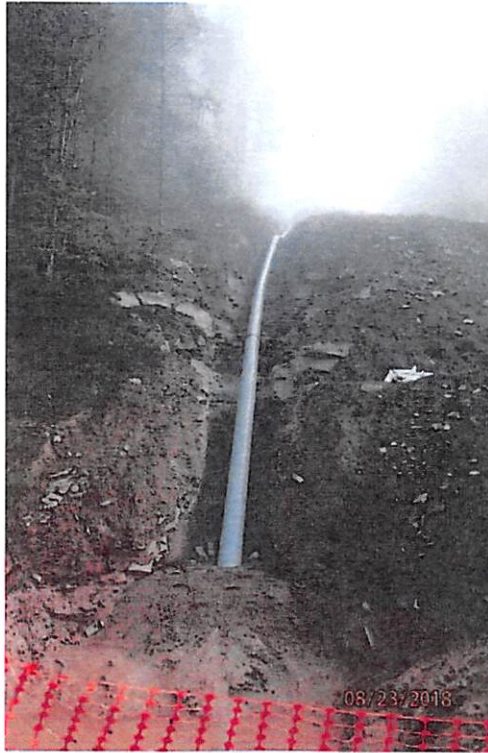
Area of open pipe trench that led to the need for the previously pictured dewatering operation in UNT Franks Run watershed.

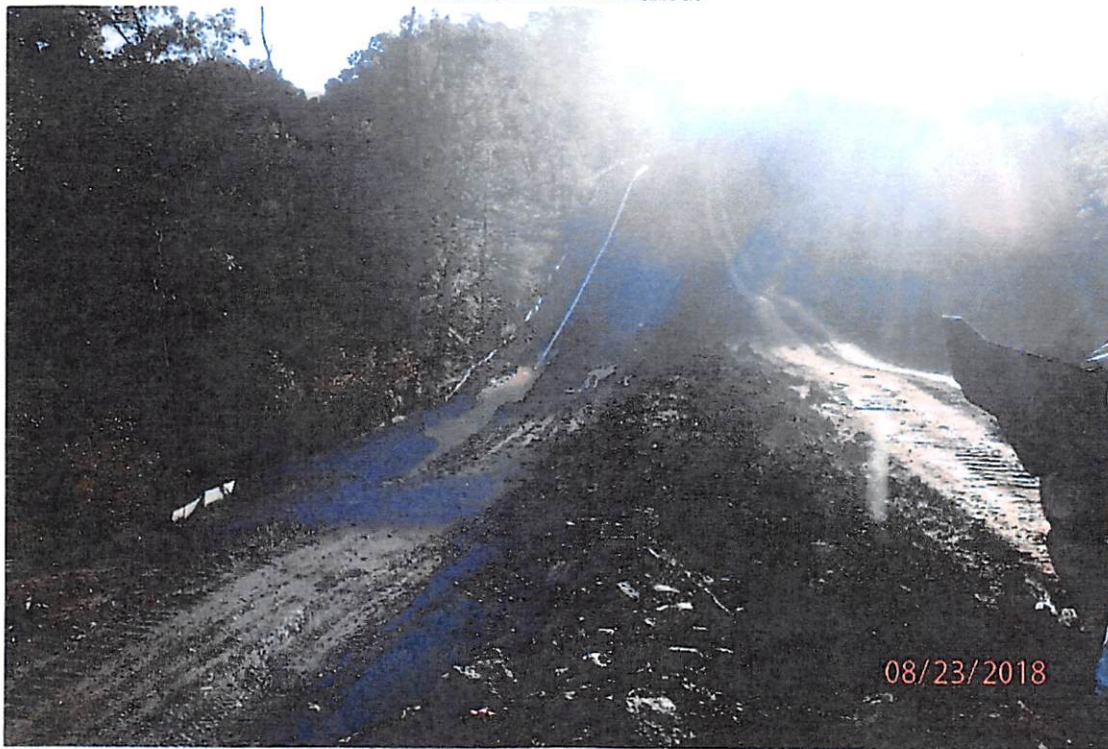
Area of open pipe trench that led to the need for the previously pictured dewatering operation in UNT Franks Run watershed. This area lacked the installed water bars that was described in the approved SWPPP.

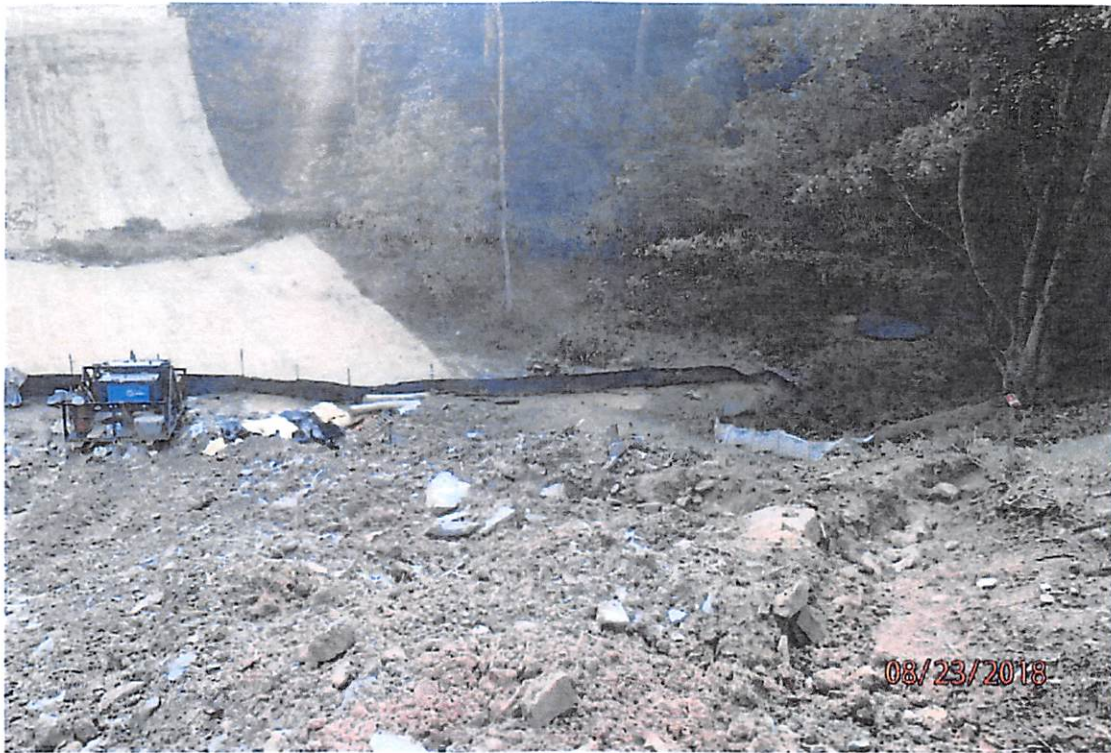
Overview of dewatering adjacent to UNT Beverlyn Fork (UNT129).

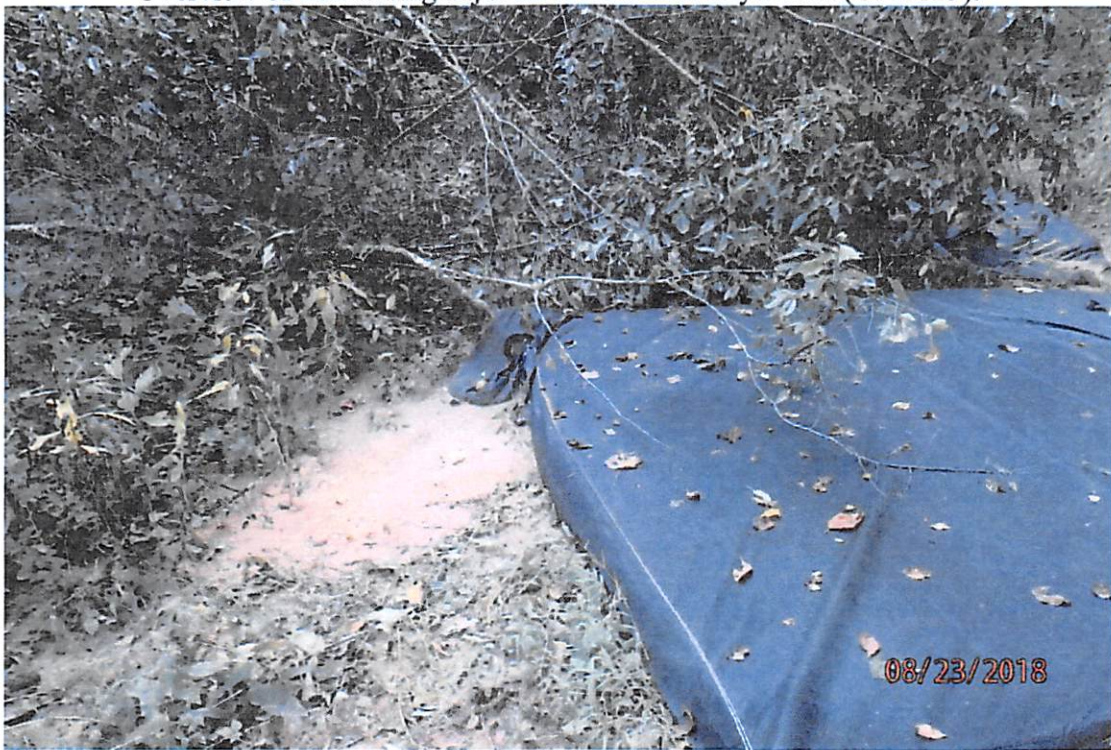
Offsite sediment deposits below dewatering bag that lead to the receiving stream.

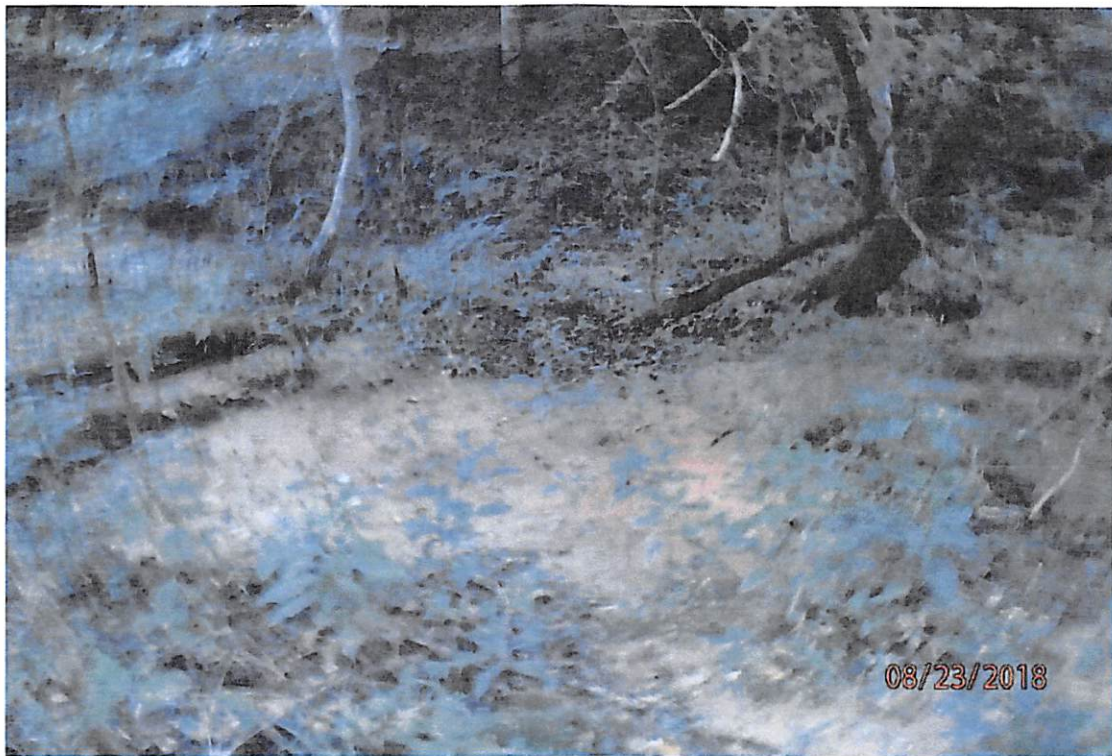
Offsite sediment deposits below dewatering bag that lead to the receiving stream at UNT 129.

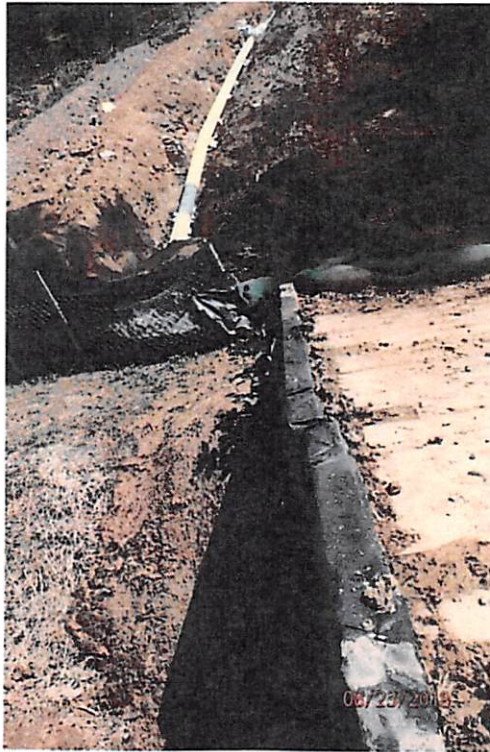
BMPs that were overwhelmed due to flow from the open pipe trench adjacent to crossing #23 (UNT 133).

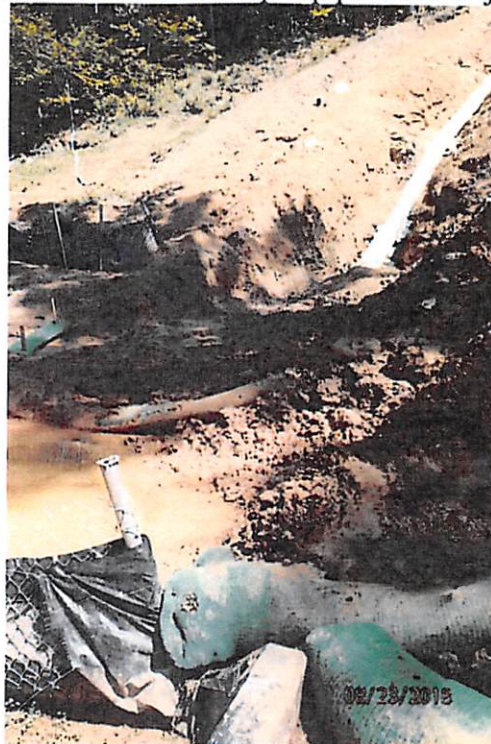
BMPs that were overwhelmed due to flow from the open pipe trench adjacent to crossing #23 (UNT 133)
that led to offsite CNA.

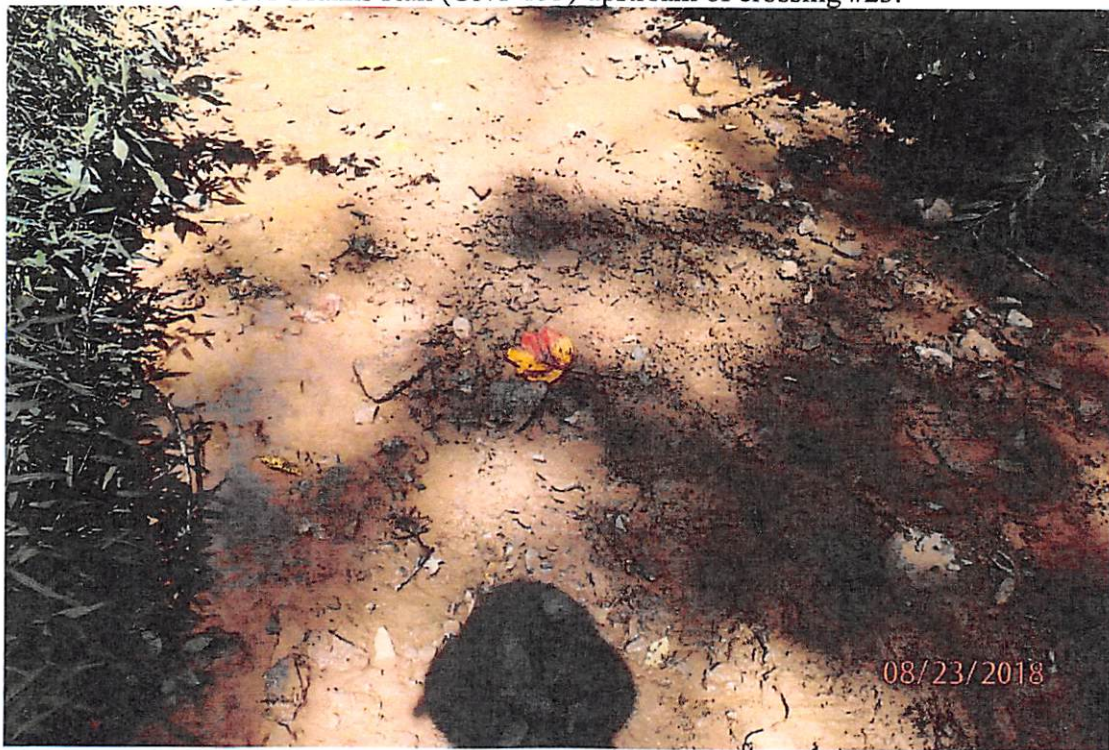
UNT Franks Run (UNT 133) downstream of crossing #23. Offsite CNA deposits in UNT Franks Run
(39° 25.885' X 80° 37.133') pictured.

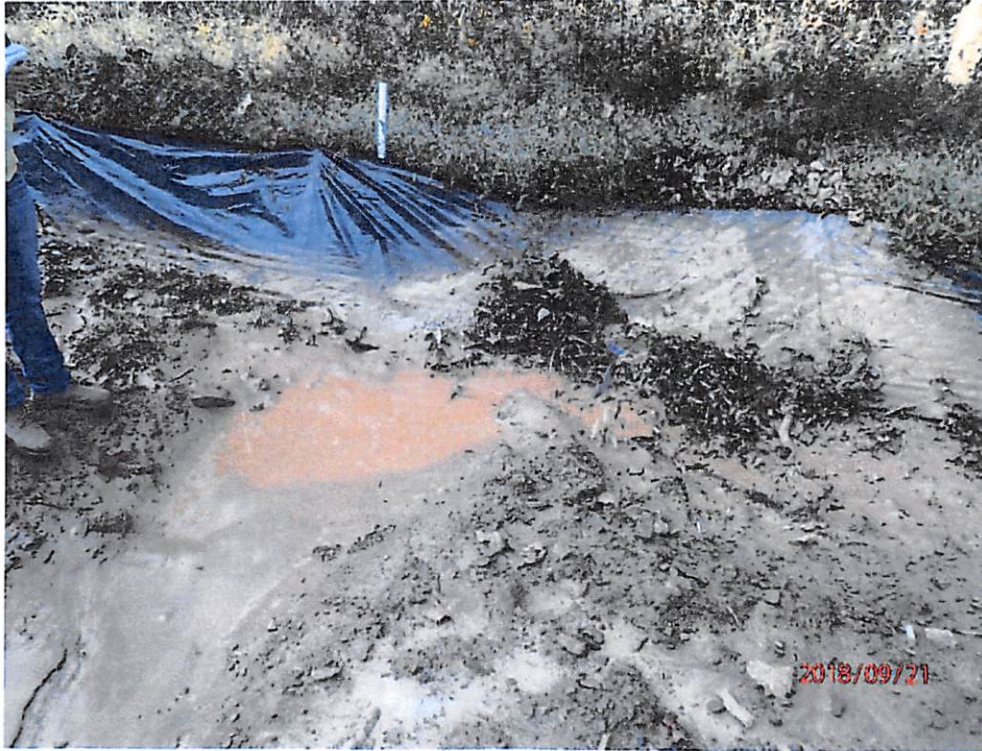
Sediment leaving project through super silt fence in need of maintenance near Archers Fork access.

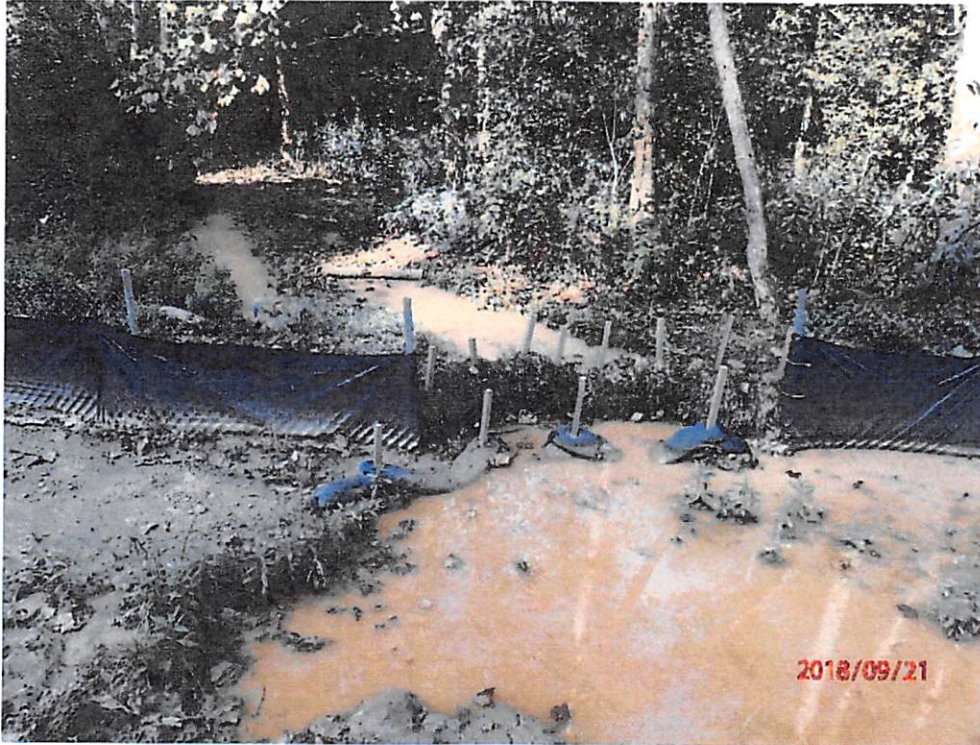
Sediment leaving project through super silt fence in need of maintenance near Aches Fork Road.
